GREENJACKET[®]

Post-Installation Care

Greenjacket Post-Installation Care

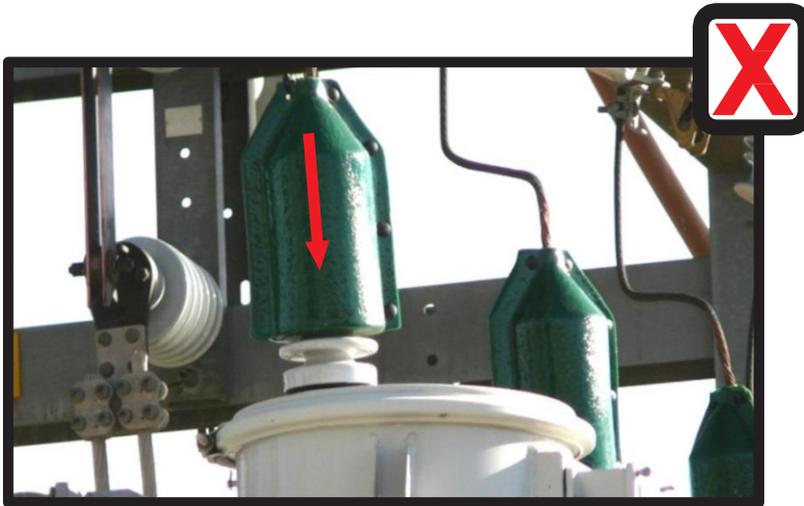
Incorrectly installed product over multiple sheds

Greenjacket products are installed correctly initially, however, an apparatus taken out of service for regular maintenance can have the product reapplied incorrectly. Greenjacket products are designed to fit sitting on the top insulator shed or enclosing the top-most shed only. Installing any protective products including Greenjacket over more than one or in some cases all the sheds will compromise the insulator's BIL rating. Consequently subjecting the surface of protective covers to high electrical stress that can result in a flashover.

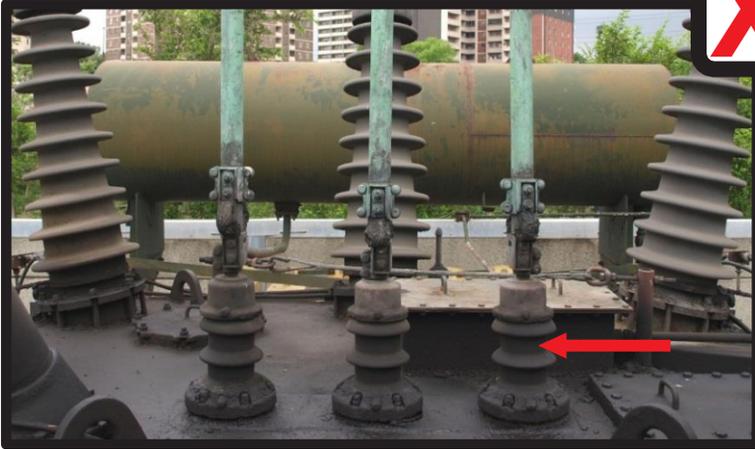
Contaminated bushing sheds

Proper insulation maintenance is required at locations considered to be highly contaminated (i.e. Equivalent Salt Deposit Density monitored) road salt and/or other airborne semi-conductive contaminants can build up on insulator sheds causing eventual surface tracking and reducing an insulator's performance. Resulting tracking can place severe electrical stress on the service of installed cover-up resulting in a flashover.

When contaminated insulators require washing, Greenjacket covers can also be cleaned if necessary. Careful attention should be taken to ensure covers are not dislodged while being cleaned and that their original intended position is maintained.

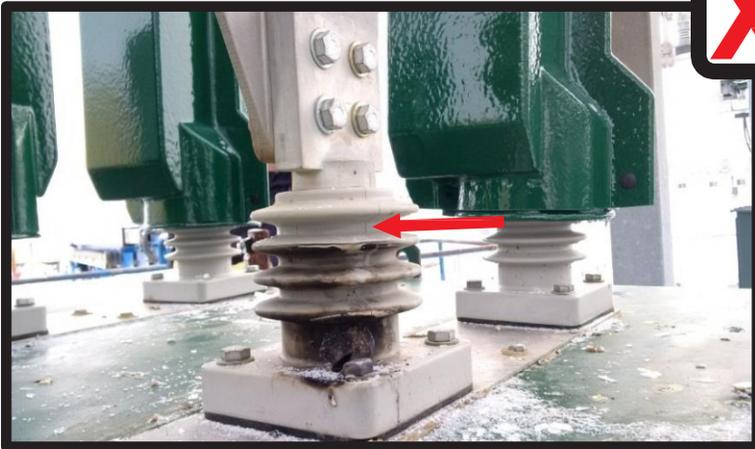
Hairline crack in insulator due to uneven torquing during bushing installation

Insulation and connectors are visually inspected to ensure both are in good working order prior to having cover-up installed. However, cracked or damaged insulation or loose electrical connections can result in a flashover at that location. Greenjacket products should never be installed on damaged or malfunctioning equipment.
